**Flood Control Project Maintenance
Levee Inspections**

Fall 2012 Levee Maintenance Deficiency Summary Report

San Joaquin River Basin

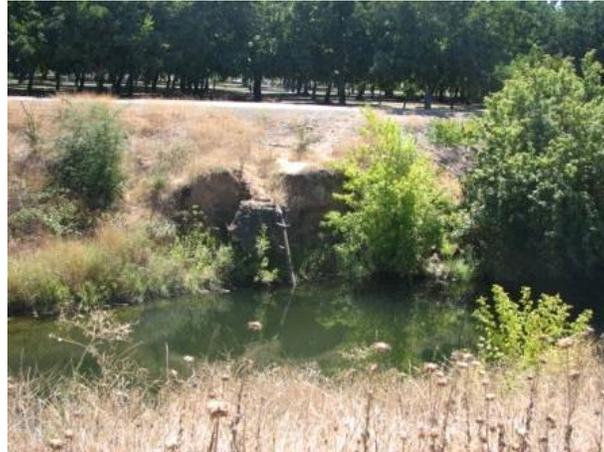
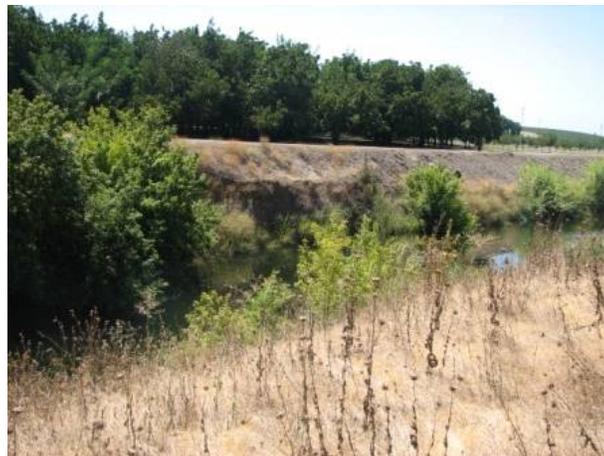
Levee Mile Report Line	11
Start Levee Mile	0.97
End Levee Mile	0.99
Location	Water Side
Category	Supplemental
Item	DWR Erosion Survey
Front view of erosion. Note the drainage pipe at the site.	
SJR2012_NA0017U16RM22.74_1.jpg

Levee Mile Report Line	11
Start Levee Mile	0.97
End Levee Mile	0.99
Location	Water Side
Category	Supplemental
Item	DWR Erosion Survey
Looking downstream	
SJR2012_NA0017U16RM22.74_2.jpg

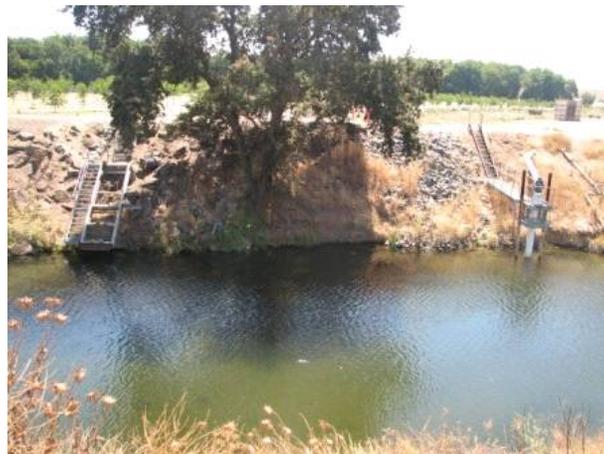
Levee Mile Report Line	12
Start Levee Mile	1.13
End Levee Mile	1.13
Location	Water Side
Category	Supplemental
Item	DWR Erosion Survey
Front view of erosion. Erosion is next to a tree at the levee toe.	
SJR2012_NA0017U16RM22.58_1.jpg

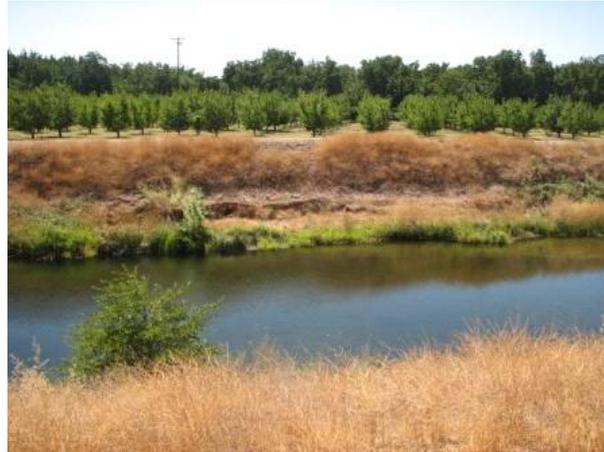
SJR2012_NA0017U16RM22.15_1.jpg

Front view of erosion.

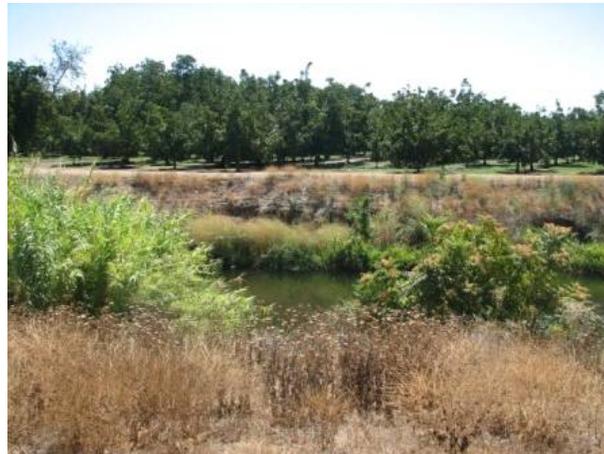
SJR2012_NA0017U16RM22.01_1.jpg

Levee Mile Report Line	17
Start Levee Mile	1.74
End Levee Mile	1.75
Location	Water Side
Category	Supplemental
Item	DWR Erosion Survey

Front view of erosion site. A pocket erosion is at the downstream

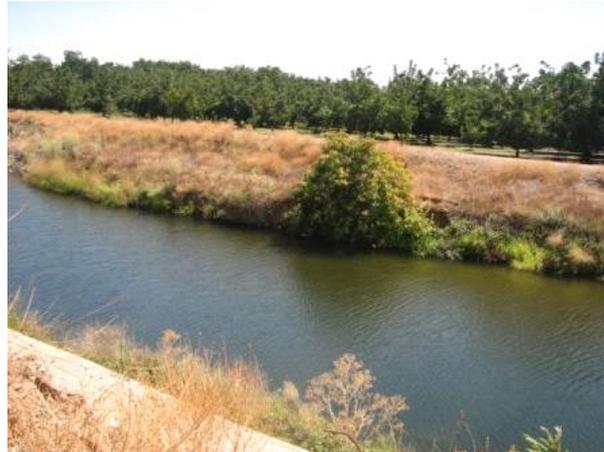
SJR2012_NA0017U16RM21.95_1.jpg

Levee Mile Report Line	18
Start Levee Mile	1.75
End Levee Mile	1.76
Location	Water Side
Category	Supplemental
Item	DWR Erosion Survey

Front view of erosion site

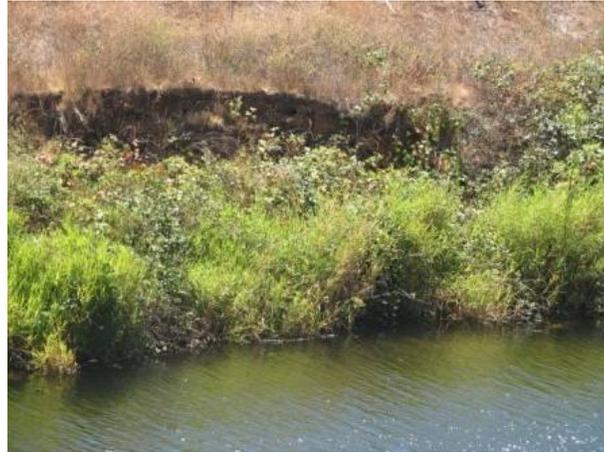
SJR2012_NA0017U16RM21.94_1.jpg

Close view of the erosion

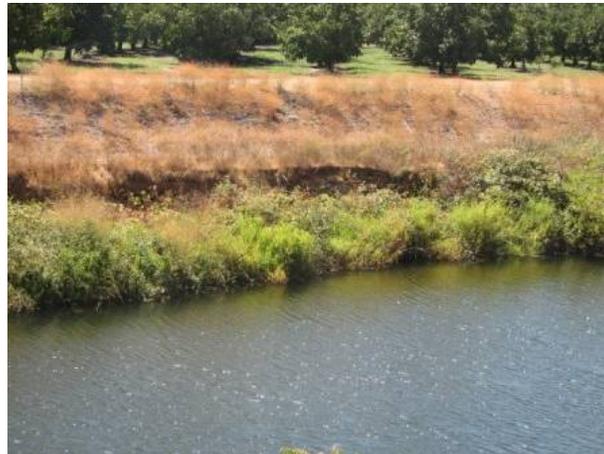
SJR2012_NA0017U16RM21.94_2.jpg

Levee Mile Report Line	19
Start Levee Mile	1.77
End Levee Mile	1.78
Location	Water Side
Category	Supplemental
Item	DWR Erosion Survey

Looking downstream at the erosion

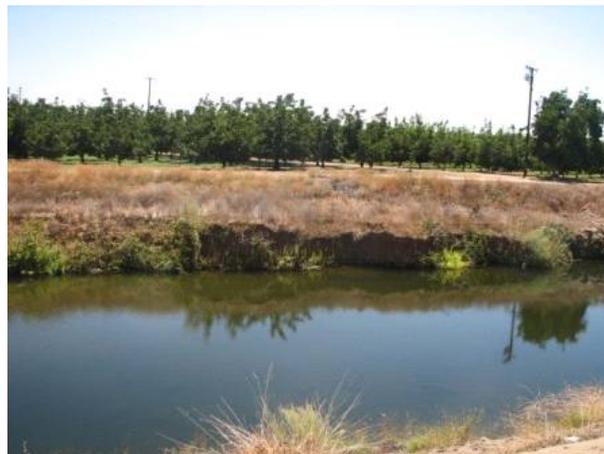
SJR2012_NA0017U16RM21.05_1.jpg

Levee Mile Report Line	21
Start Levee Mile	1.93
End Levee Mile	1.95
Location	Water Side
Category	Supplemental
Item	DWR Erosion Survey

Looking downstream at the erosion site

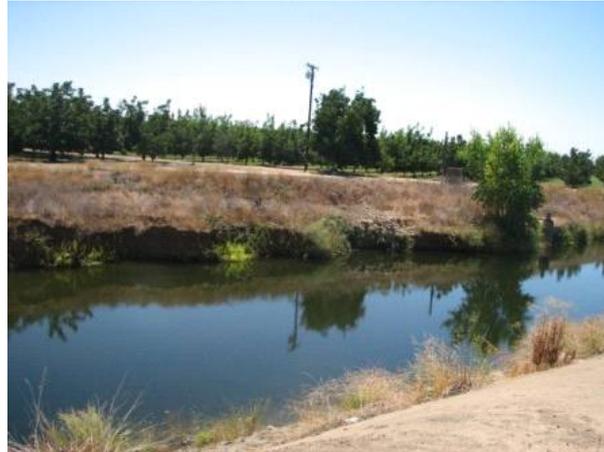
Levee Mile Report Line	21
Start Levee Mile	1.93
End Levee Mile	1.95
Location	Water Side
Category	Supplemental
Item	DWR Erosion Survey
Looking downstream at the erosion	
SJR2012_NA0017U16RM21.05_2.jpg

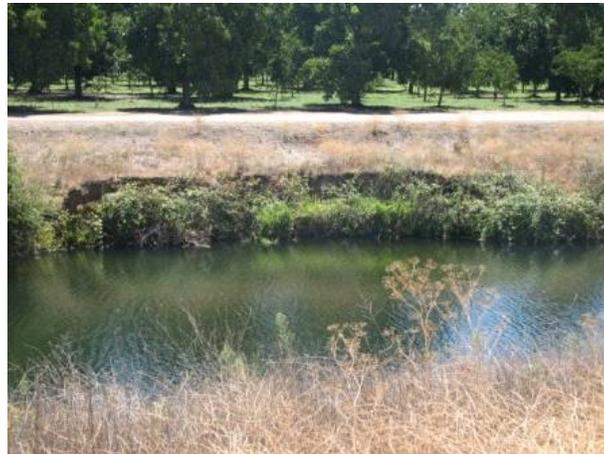
Levee Mile Report Line	24
Start Levee Mile	2.31
End Levee Mile	2.32
Location	Water Side
Category	Supplemental
Item	DWR Erosion Survey
Front view of the erosion.	
SJR2012_NA0017U16RM20.71_1.jpg

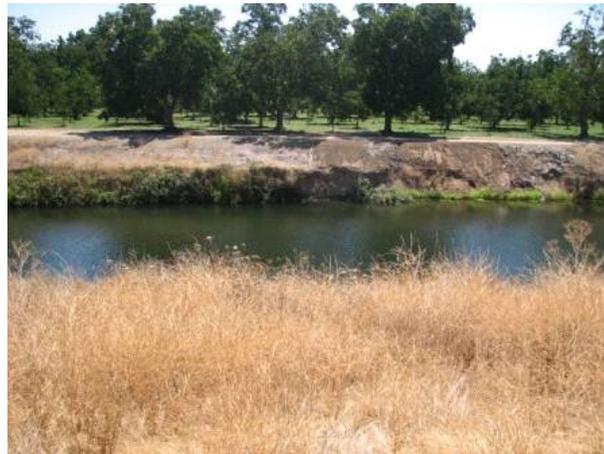
Levee Mile Report Line	25
Start Levee Mile	2.37
End Levee Mile	2.38
Location	Water Side
Category	Supplemental
Item	DWR Erosion Survey
Front view of the site.	
SJR2012_NA0017U16RM20.62_1.jpg

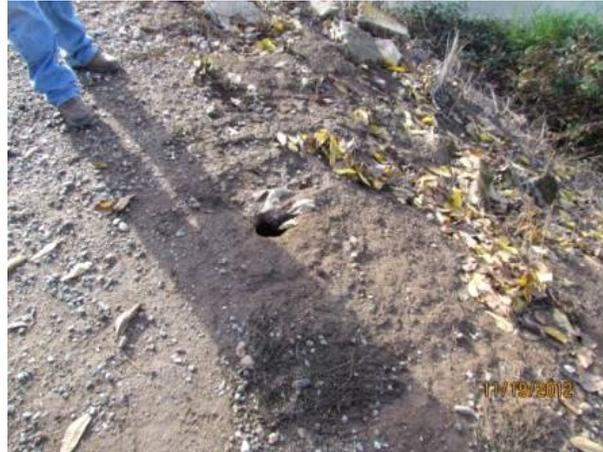
Levee Mile Report Line	26
Start Levee Mile	2.41
End Levee Mile	2.41
Location	Water Side
Category	Earthen Levee
Item	Animal Control
<p>Animal hole was found on the waterside shoulder of the levee looking downstream.</p>	
<p>pkazi_f_20121121_145.jpg</p>

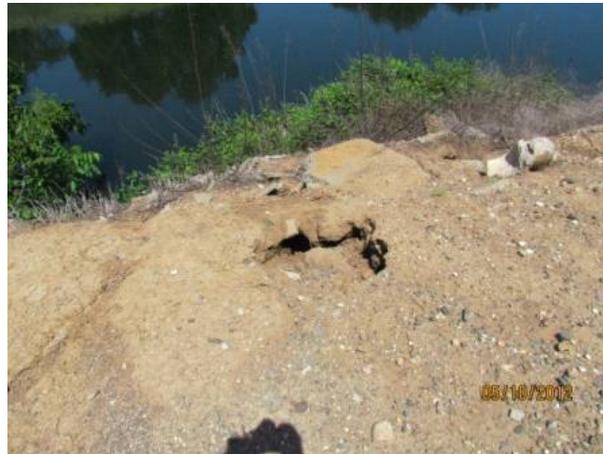
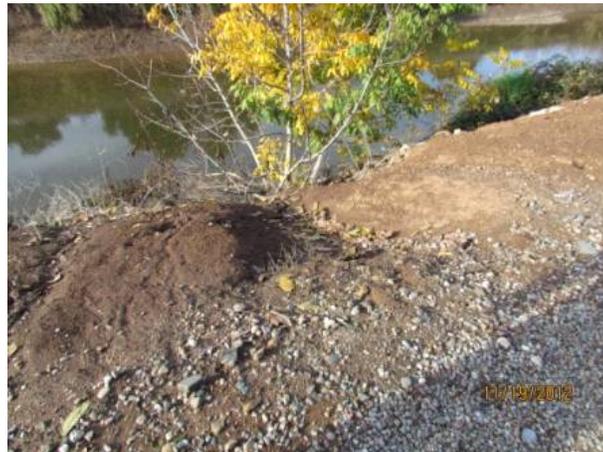
Levee Mile Report Line	27
Start Levee Mile	2.42
End Levee Mile	2.42
Location	Water Side
Category	Earthen Levee
Item	Slope Stability
<p>Slope instability was found on the waterside of the levee looking upstream.</p>	
<p>pkazi_f_20120913_557.jpg</p>

Levee Mile Report Line	27
Start Levee Mile	2.42
End Levee Mile	2.42
Location	Water Side
Category	Earthen Levee
Item	Slope Stability
<p>Updated picture of the slope instability on the waterside shoulder of the levee looking upstream.</p>	
<p>pkazi_f_20121121_144.jpg</p>

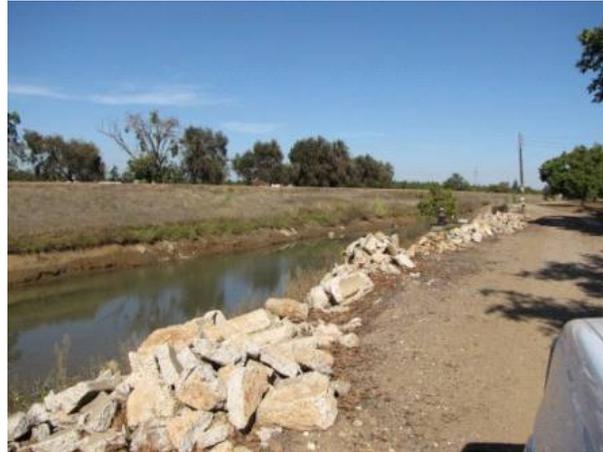
Levee Mile Report Line	28
Start Levee Mile	2.47
End Levee Mile	2.50
Location	Water Side
Category	Earthen Levee
Item	Encroachments
View of concrete debris on waterward side looking upstream.	
pkazi_f_20120913_538.jpg

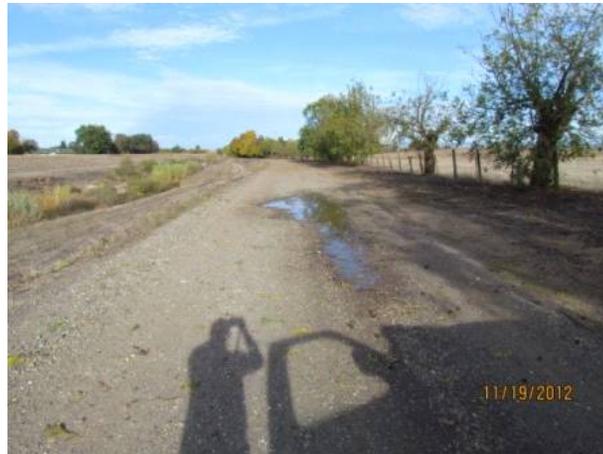
Levee Mile Report Line	30
Start Levee Mile	2.65
End Levee Mile	2.65
Location	Crown
Category	Earthen Levee
Item	Crown Surface / Depressions / Rutting
Crown depression was found on the access road looking upstream.	
pkazi_f_20121121_143.jpg

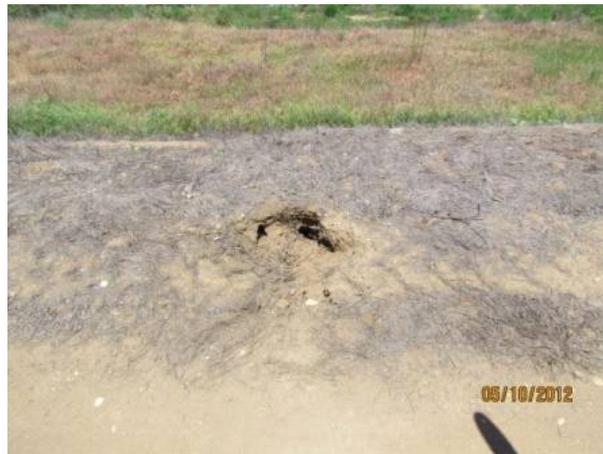
Levee Mile Report Line	31
Start Levee Mile	2.66
End Levee Mile	2.66
Location	Water Side
Category	Earthen Levee
Item	Animal Control
Animal holes were found on the waterside of the levee looking upstream.	
pkazi_f_20120913_556.jpg

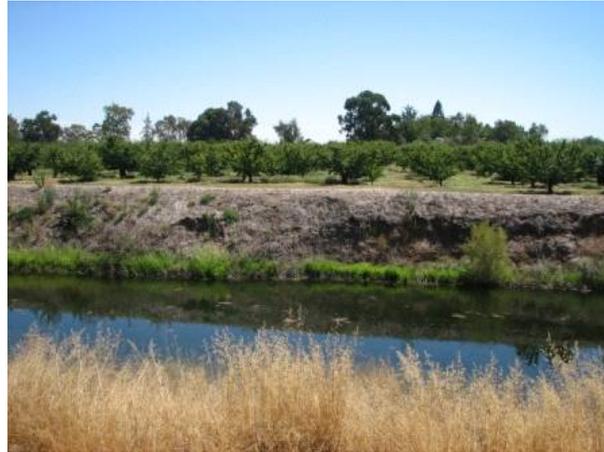
SJR2012_NA0017U16RM20_1.jpg

Front view of the erosion.

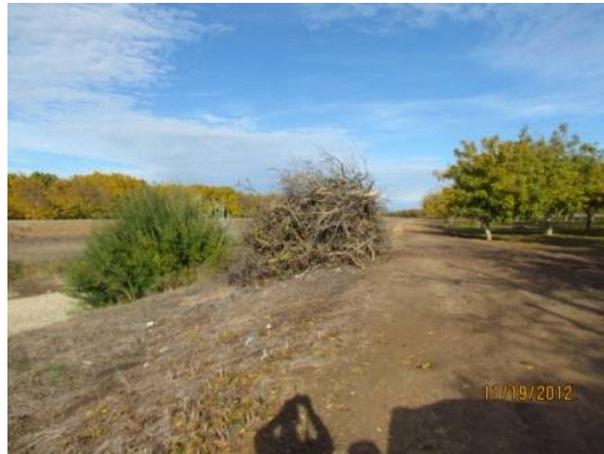
Levee Mile Report Line	33
Start Levee Mile	3.35
End Levee Mile	3.35
Location	Water Side
Category	Earthen Levee
Item	Encroachments

Pruning was found on the waterside shoulder of the levee looking upstream.

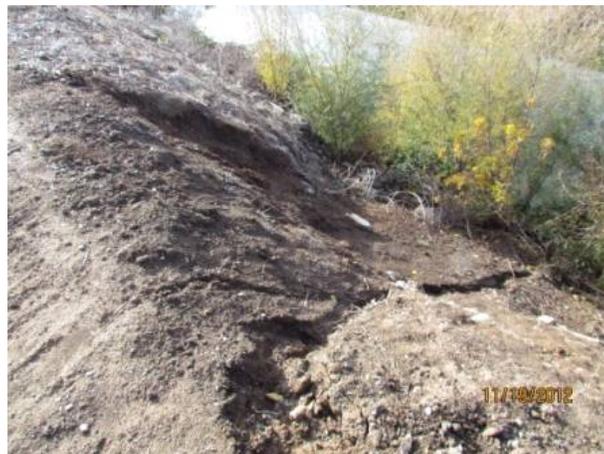
Levee Mile Report Line	35
Start Levee Mile	3.65
End Levee Mile	3.65
Location	Water Side
Category	Earthen Levee
Item	Slope Stability

Slope instability was found on the waterside slope of the levee looking downstream.

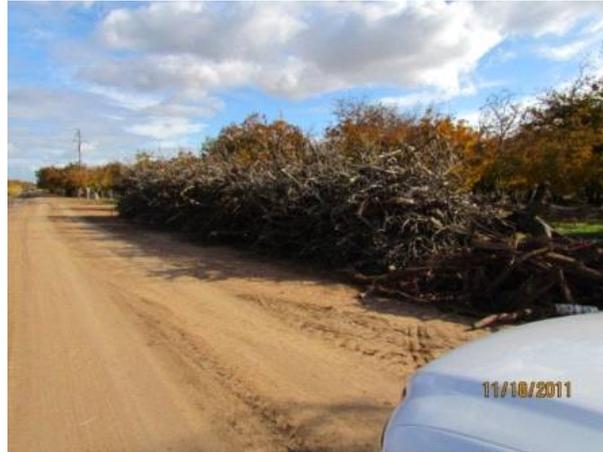
Levee Mile Report Line	36
Start Levee Mile	3.66
End Levee Mile	3.66
Location	Land Side
Category	Earthen Levee
Item	Encroachments
Prunings were found on the landside of the levee looking upstream.	
pkazi_f_20120913_552.jpg

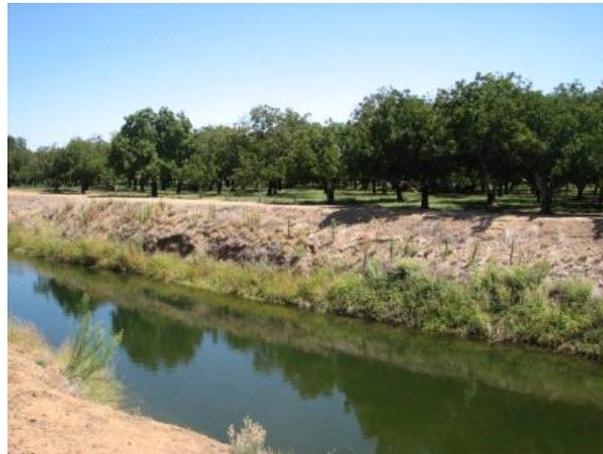
Levee Mile Report Line	38
Start Levee Mile	3.78
End Levee Mile	3.79
Location	Water Side
Category	Supplemental
Item	DWR Erosion Survey
Looking upstream	
SJR2012_NA0017U16RM19.28_1.jpg

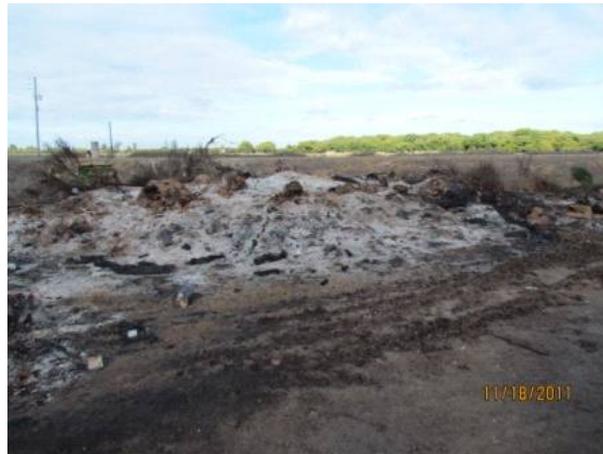
Levee Mile Report Line	39
Start Levee Mile	3.78
End Levee Mile	3.78
Location	Water Side
Category	Earthen Levee
Item	Encroachments
Prunings were found on the waterside of the levee looking upstream.	
pkazi_f_20120913_452.jpg

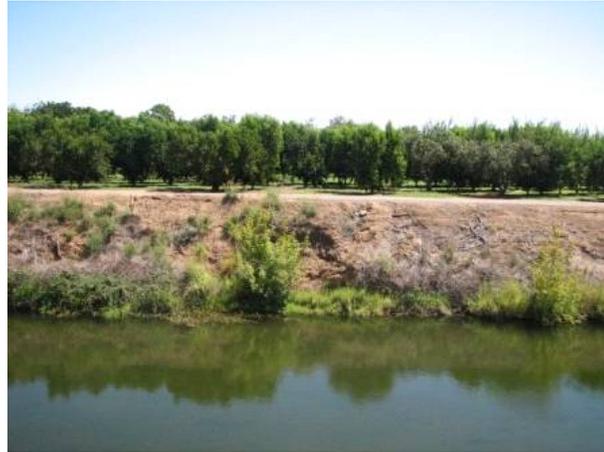
SJR2012_NA0017U16RM19.23_1.jpg

Front view of erosion

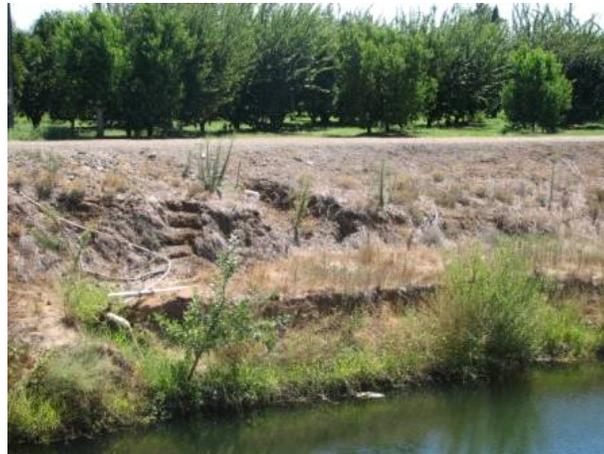
SJR2012_NA0017U16RM19.18_1.jpg

Levee Mile Report Line	42
Start Levee Mile	3.89
End Levee Mile	3.91
Location	Water Side
Category	Supplemental
Item	DWR Erosion Survey

Close look at the erosion. Note the erosion at the levee slope as well as berm.

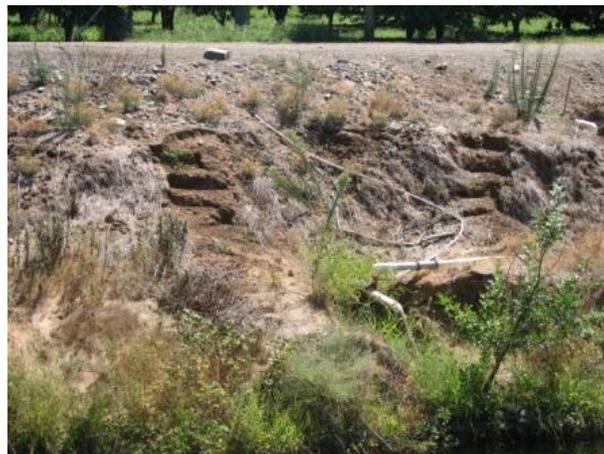
SJR2012_NA0017U16RM19.18_2.jpg

Levee Mile Report Line	42
Start Levee Mile	3.89
End Levee Mile	3.91
Location	Water Side
Category	Supplemental
Item	DWR Erosion Survey

A closer look at the erosion

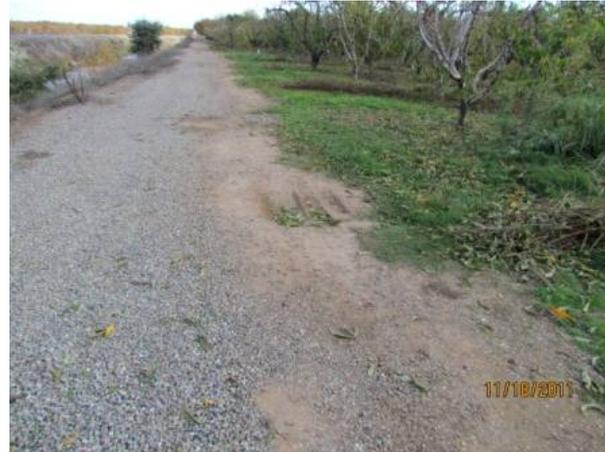
Levee Mile Report Line	43
Start Levee Mile	3.91
End Levee Mile	3.91
Location	Crown
Category	Earthen Levee
Item	Crown Surface / Depressions / Rutting
Depression was found on the crown of the levee looking upstream.	
pkazi_f_20120913_563.jpg

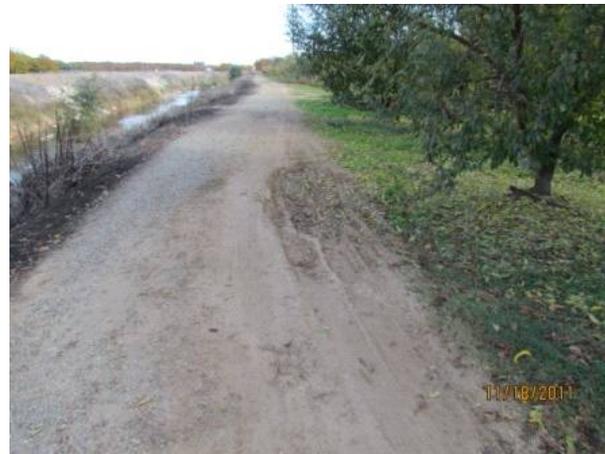
Levee Mile Report Line	44
Start Levee Mile	3.96
End Levee Mile	3.96
Location	Crown
Category	Earthen Levee
Item	Crown Surface / Depressions / Rutting
Depression was found on the crown of the levee looking upstream.	
pkazi_f_20120913_562.jpg

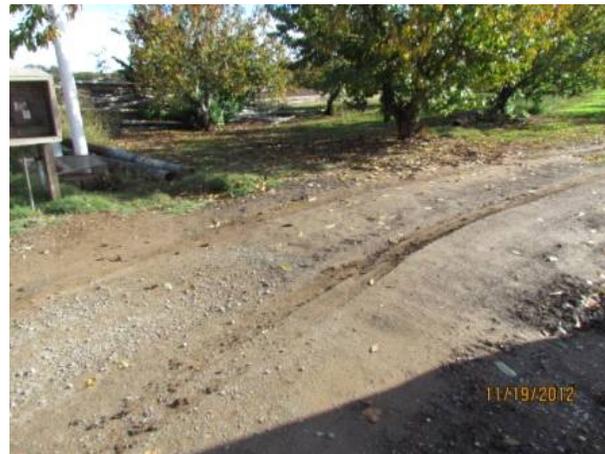
Levee Mile Report Line	45
Start Levee Mile	4.31
End Levee Mile	4.31
Location	Crown
Category	Earthen Levee
Item	Encroachments
The depression due to broken pipe on the crown of the levee was repaired by the farmer. The picture was taken from the crown looking downstream.	
pkazi_f_20121121_140.jpg

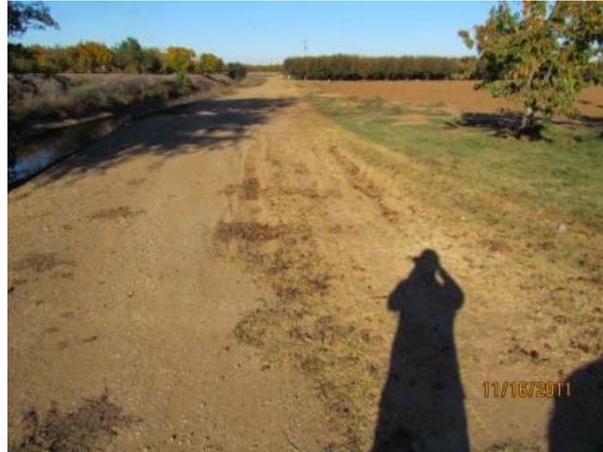
Levee Mile Report Line	46
Start Levee Mile	4.31
End Levee Mile	4.31
Location	Crown
Category	Earthen Levee
Item	Crown Surface / Depressions / Rutting
Depression was found on the crown of the levee looking upstream.	
pkazi_f_20120913_536.jpg

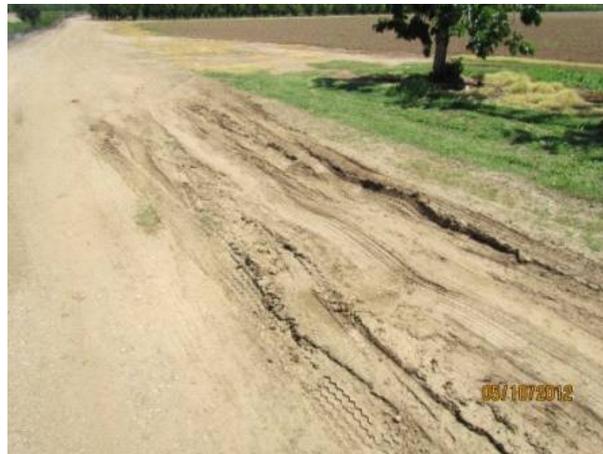
Levee Mile Report Line	46
Start Levee Mile	4.31
End Levee Mile	4.31
Location	Crown
Category	Earthen Levee
Item	Crown Surface / Depressions / Rutting
Depression and ruts were found on the crown of the levee looking upstream. This picture was taken during spring 2012 inspection.	
pkazi_f_20120913_537.jpg

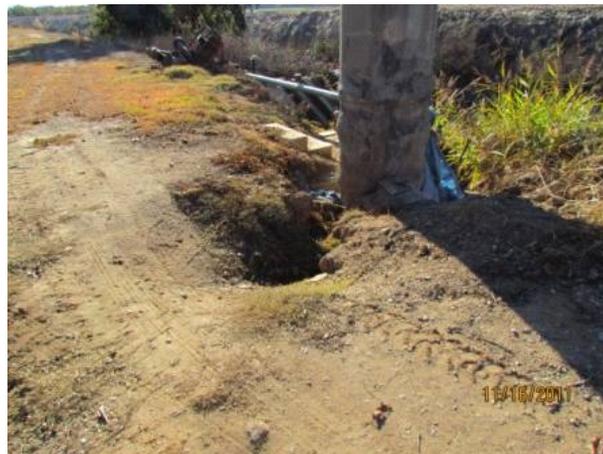
Levee Mile Report Line	47
Start Levee Mile	4.32
End Levee Mile	4.32
Location	Water Side
Category	Earthen Levee
Item	Slope Stability
Slope instability was found on the waterside of the levee looking downstream.	
pkazi_f_20120913_584.jpg

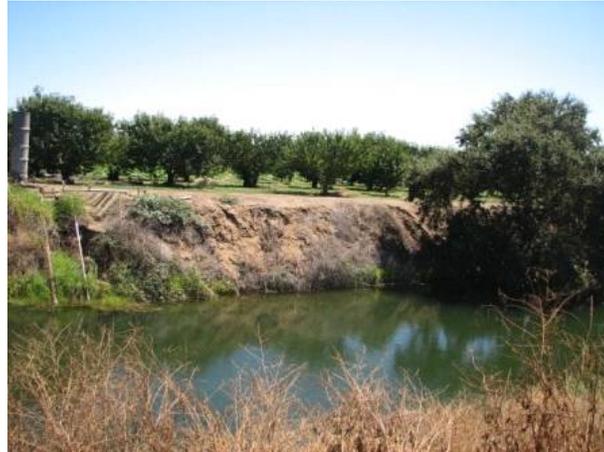
Levee Mile Report Line	48
Start Levee Mile	4.32
End Levee Mile	4.34
Location	Water Side
Category	Supplemental
Item	DWR Erosion Survey
Front view of erosion. Note the irrigation pipe and the tree	
SJR2012_NA0017U16RM18.69_1.jpg

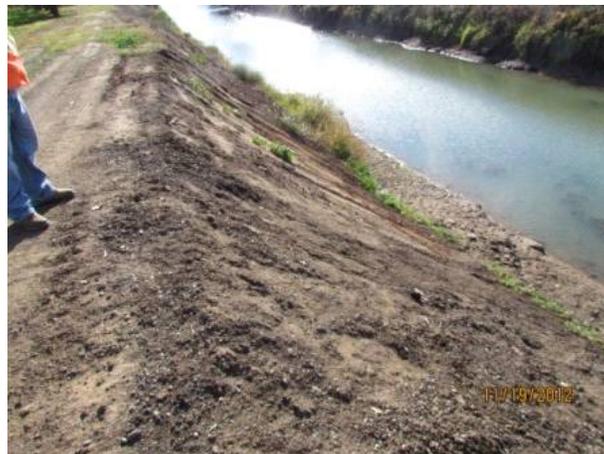
Levee Mile Report Line	53
Start Levee Mile	4.51
End Levee Mile	4.51
Location	Water Side
Category	Earthen Levee
Item	Erosion / Bank Caving
Erosion was repaired by the LMA on the waterside slope of the levee looking downstream.	
pkazi_f_20121121_139.jpg

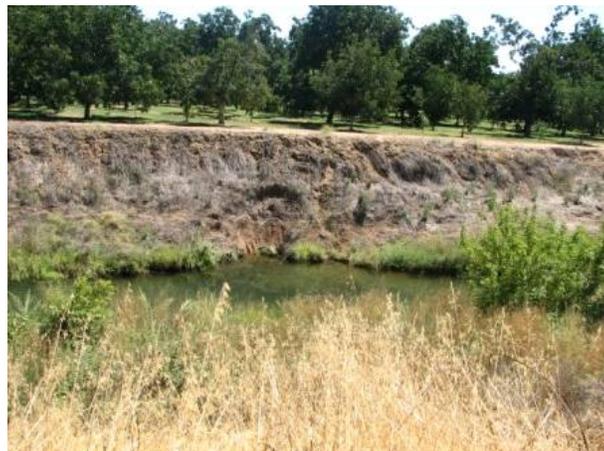
Levee Mile Report Line	56
Start Levee Mile	5.03
End Levee Mile	5.03
Location	Water Side
Category	Supplemental
Item	DWR Erosion Survey
Front view of erosion	
SJR2012_NA0017U16RM17.99_1.jpg

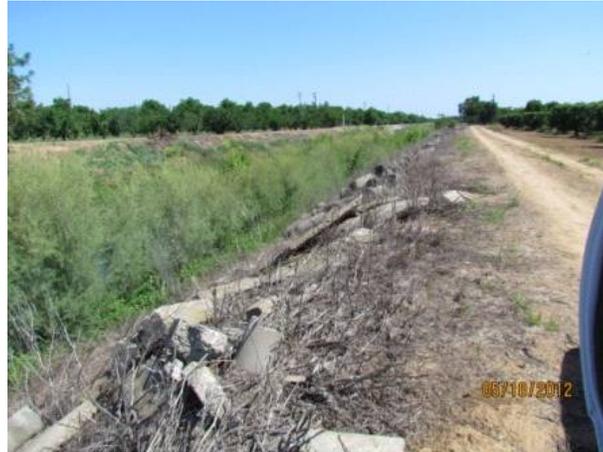
Levee Mile Report Line	57
Start Levee Mile	5.21
End Levee Mile	5.32
Location	Water Side
Category	Earthen Levee
Item	Encroachments
Debris was found on the waterside of the levee looking upstream.	
pkazi_f_20120913_544.jpg

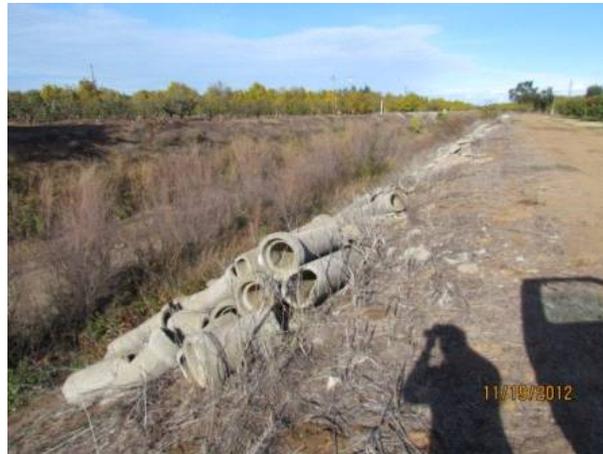
Levee Mile Report Line	57
Start Levee Mile	5.21
End Levee Mile	5.32
Location	Water Side
Category	Earthen Levee
Item	Encroachments
Concrete debris was found on the waterside slope of the levee looking upstream.	
pkazi_f_20121121_138.jpg

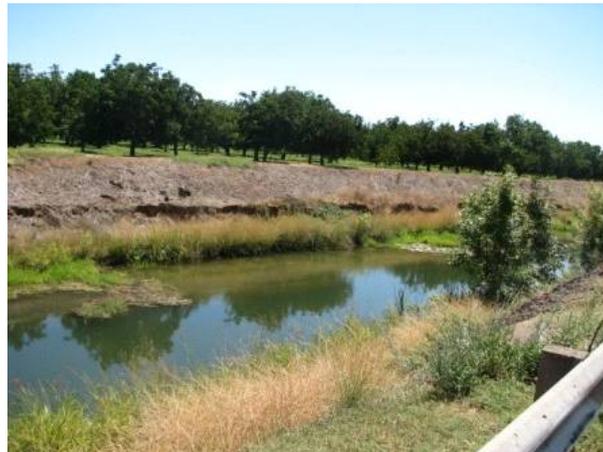
Levee Mile Report Line	60
Start Levee Mile	5.52
End Levee Mile	5.57
Location	Water Side
Category	Supplemental
Item	DWR Erosion Survey
Looking downstream at the site	
SJR2012_NA0017U16RM11.81_1.jpg

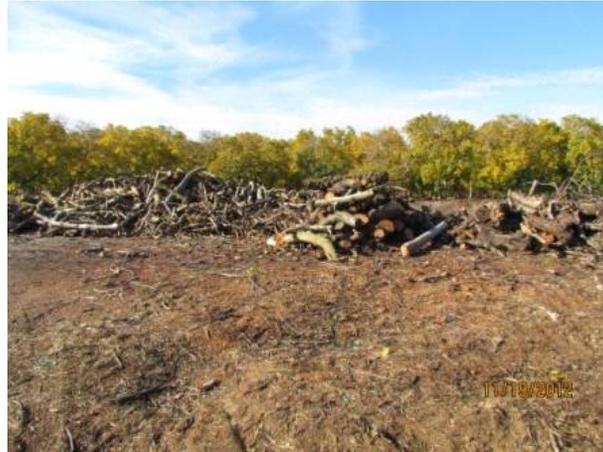
Levee Mile Report Line	61
Start Levee Mile	5.83
End Levee Mile	5.83
Location	Water Side
Category	Earthen Levee
Item	Encroachments
Prunings were found on the waterside shoulder of the levee looking upstream.	
pkazi_f_20121121_137.jpg

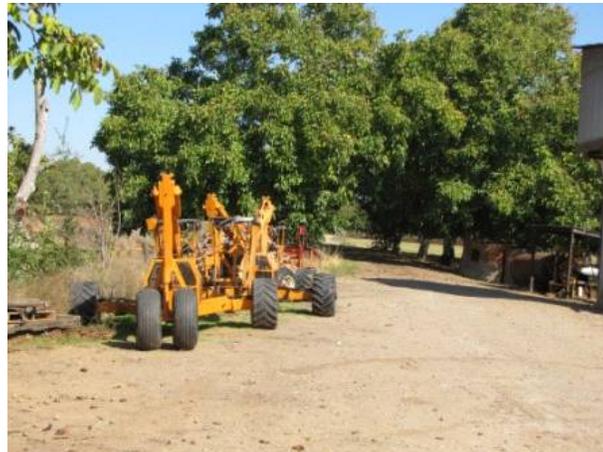
Levee Mile Report Line	63
Start Levee Mile	5.94
End Levee Mile	5.94
Location	Water Side
Category	Earthen Levee
Item	Encroachments
View of equipment located on the waterward side looking upstream.	
pkazi_f_20120913_531.jpg

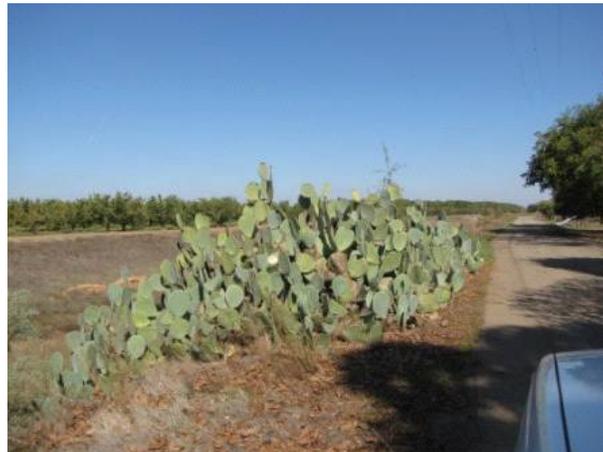
Levee Mile Report Line	66
Start Levee Mile	6.18
End Levee Mile	6.18
Location	Water Side
Category	Earthen Levee
Item	Vegetation
View of cacti located on waterward side looking upstream.	
pkazi_f_20120913_528.jpg

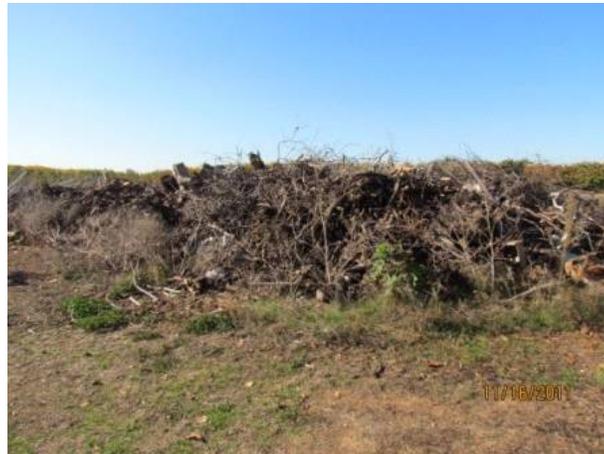
Levee Mile Report Line	74
Start Levee Mile	6.32
End Levee Mile	6.32
Location	Water Side
Category	Earthen Levee
Item	Encroachments
Prunings were found on the waterside of the levee looking upstream. This picture was taken during fall 2011 inspection.	
pkazi_f_20120913_454.jpg

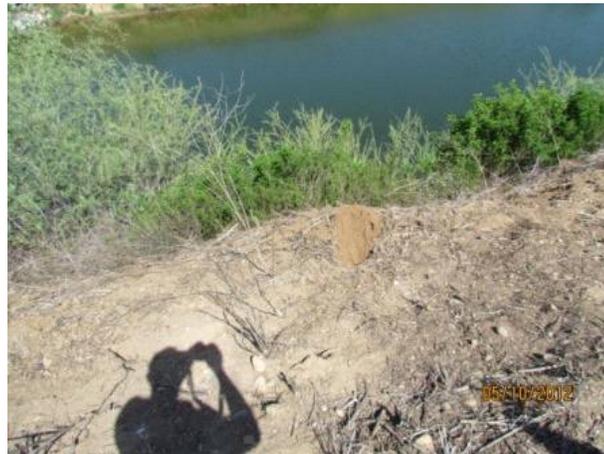
Levee Mile Report Line	75
Start Levee Mile	6.35
End Levee Mile	6.35
Location	Water Side
Category	Earthen Levee
Item	Animal Control
An animal hole was found on the waterside of the levee looking upstream.	
pkazi_f_20120913_529.jpg

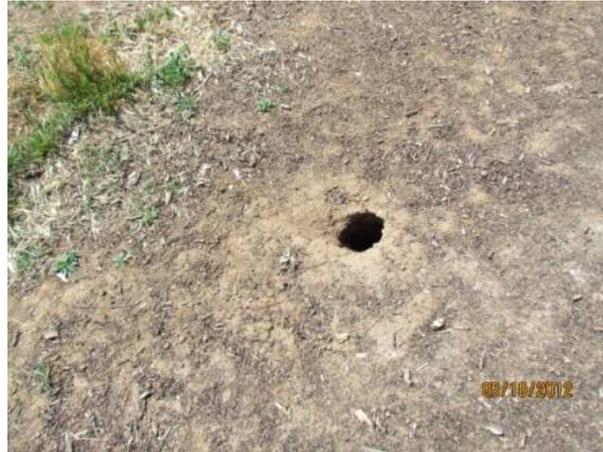
Levee Mile Report Line	76
Start Levee Mile	6.35
End Levee Mile	6.35
Location	Land Side
Category	Earthen Levee
Item	Animal Control
An animal hole was found on the landside of the levee looking upstream.	
pkazi_f_20120913_532.jpg

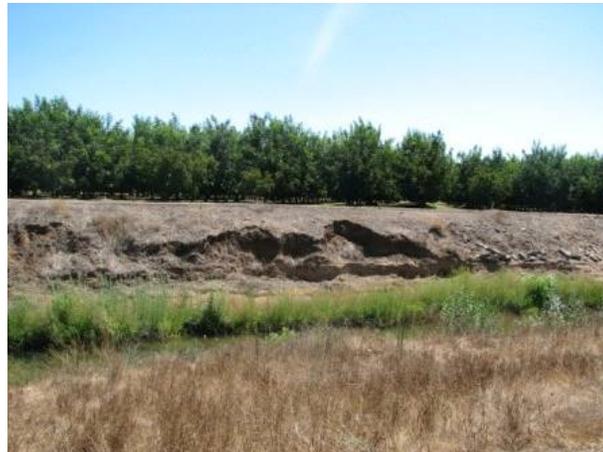
Levee Mile Report Line	80
Start Levee Mile	6.72
End Levee Mile	6.91
Location	Water Side
Category	Supplemental
Item	DWR Erosion Survey
Looking at the most downstream erosion at the site.	
SJR2012_NA0017U16RM16.27_1.jpg

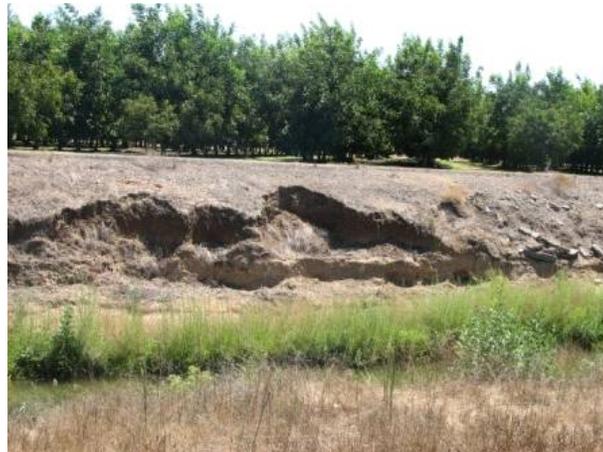
Levee Mile Report Line	80
Start Levee Mile	6.72
End Levee Mile	6.91
Location	Water Side
Category	Supplemental
Item	DWR Erosion Survey
Closer view of the erosion	
SJR2012_NA0017U16RM16.27_2.jpg

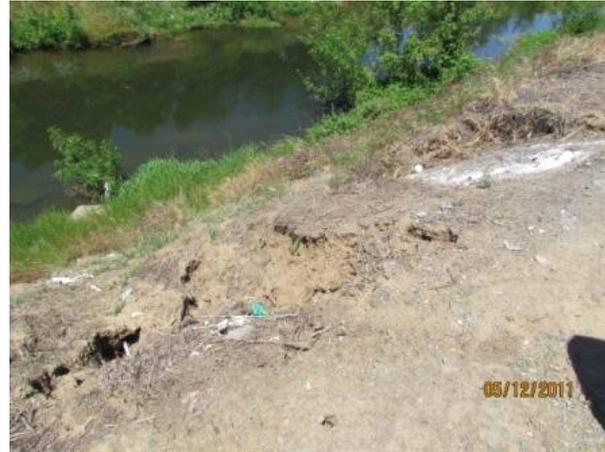
Levee Mile Report Line	82
Start Levee Mile	6.97
End Levee Mile	6.97
Location	Water Side
Category	Earthen Levee
Item	Slope Stability
Slope stability was found on the shoulder of waterside of the levee. The picture was taken from the crown looking upstream.	
pkazi_f_20120913_548.jpg

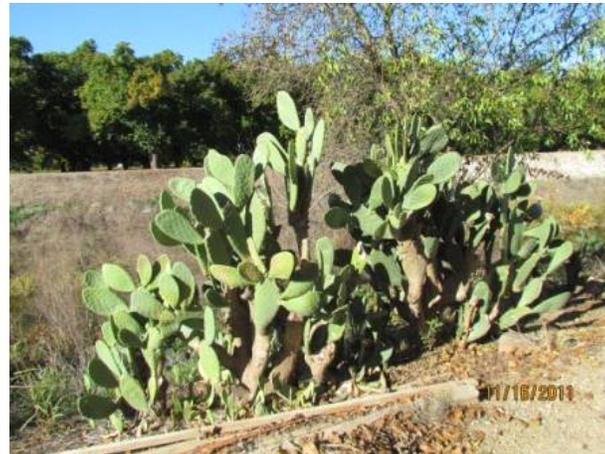
Levee Mile Report Line	83
Start Levee Mile	7.01
End Levee Mile	7.01
Location	Water Side
Category	Earthen Levee
Item	Vegetation
Cacti were found on the waterside of the levee looking upstream.	
pkazi_f_20120913_455.jpg

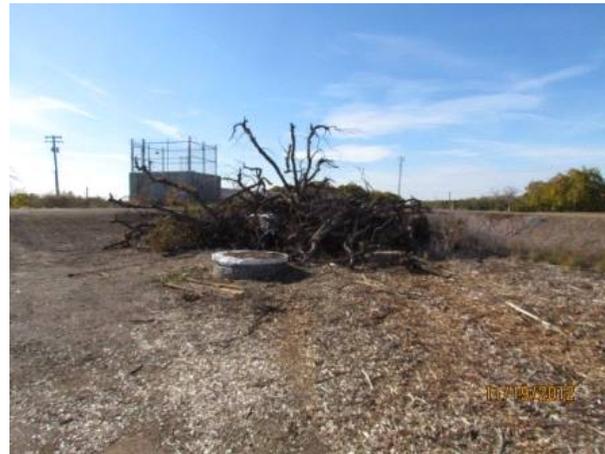
Levee Mile Report Line	85
Start Levee Mile	7.29
End Levee Mile	7.29
Location	Water Side
Category	Earthen Levee
Item	Encroachments
Prunings were found on the waterside shoulder of the levee looking downstream.	
pkazi_f_20121121_136.jpg

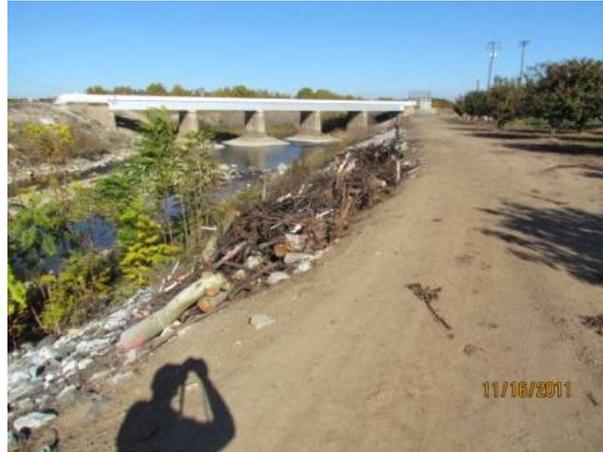
Levee Mile Report Line	86
Start Levee Mile	7.37
End Levee Mile	7.37
Location	Water Side
Category	Earthen Levee
Item	Encroachments
Debris and prunings were found on the waterside of the levee looking upstream.	
pkazi_f_20120913_456.jpg

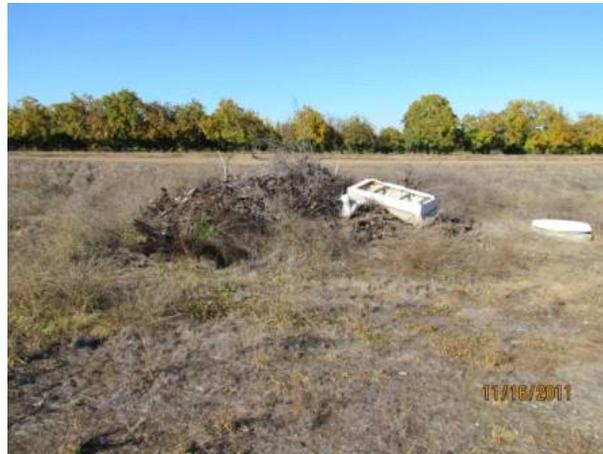
Levee Mile Report Line	87
Start Levee Mile	7.39
End Levee Mile	7.39
Location	Water Side
Category	Earthen Levee
Item	Encroachments
Debris was found on the waterside of the levee looking upstream.	
pkazi_f_20120913_583.jpg

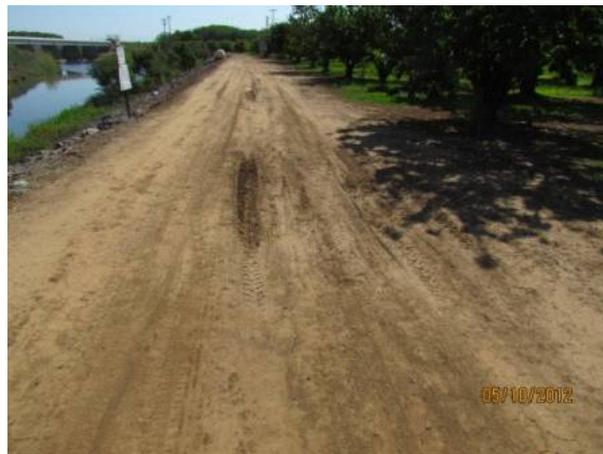
Levee Mile Report Line	89
Start Levee Mile	7.50
End Levee Mile	7.50
Location	Crown
Category	Earthen Levee
Item	Crown Surface / Depressions / Rutting
Depression due to vehicular traffic was found on the crown of the levee looking upstream.	
pkazi_f_20120913_527.jpg

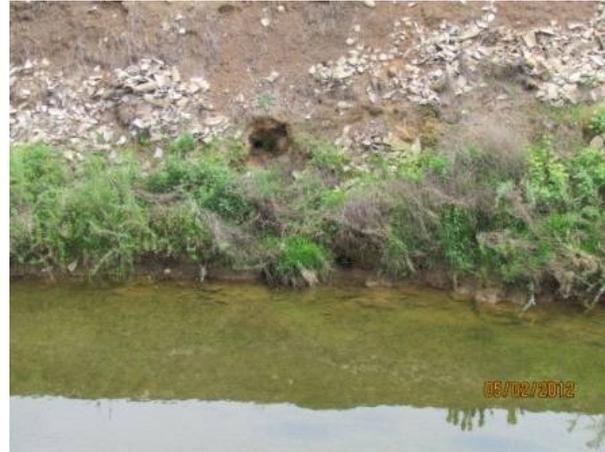
pkazi_f_20120913_561.jpg

A possible beaver den was found on waterside slope of the levee. The picture was taken from the opposite bank of the levee.

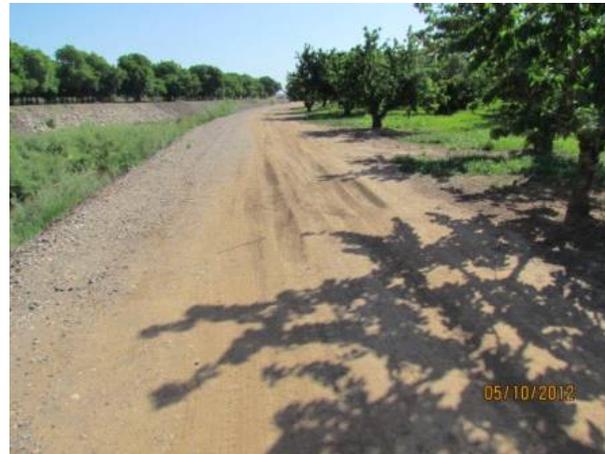
pkazi_f_20120913_526.jpg

Levee Mile Report Line	91
Start Levee Mile	7.59
End Levee Mile	7.59
Location	Crown
Category	Earthen Levee
Item	Crown Surface / Depressions / Rutting

Depression due to vehicular traffic was found on the crown of the levee looking upstream.

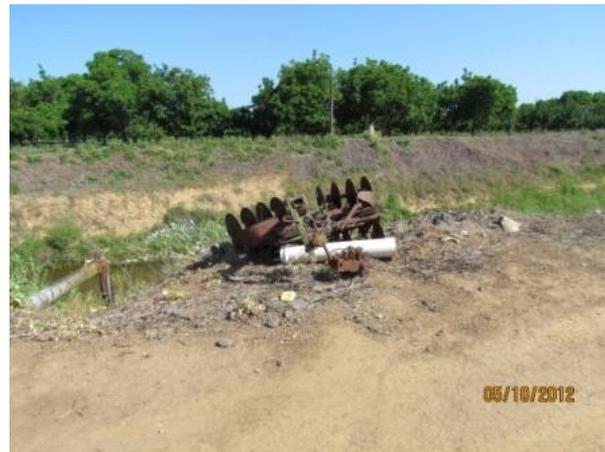
pkazi_f_20120913_525.jpg

Levee Mile Report Line	93
Start Levee Mile	7.68
End Levee Mile	7.68
Location	Water Side
Category	Earthen Levee
Item	Encroachments

Equipment was found on the waterside of the levee looking upstream.

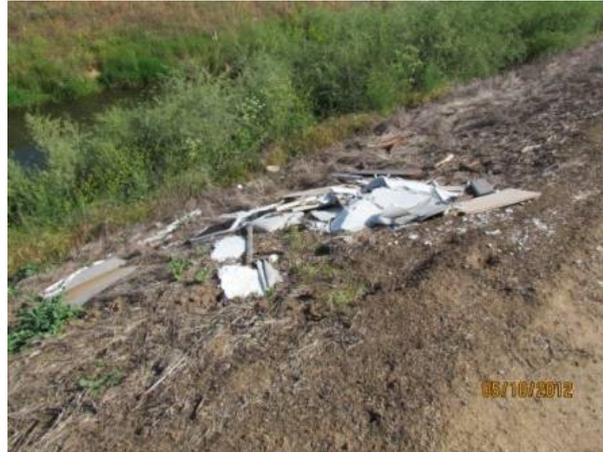
Levee Mile Report Line	96
Start Levee Mile	8.00
End Levee Mile	8.00
Location	Water Side
Category	Earthen Levee
Item	Encroachments
Debris was found on the waterside of the levee looking upstream.	
pkazi_f_20120913_520.jpg

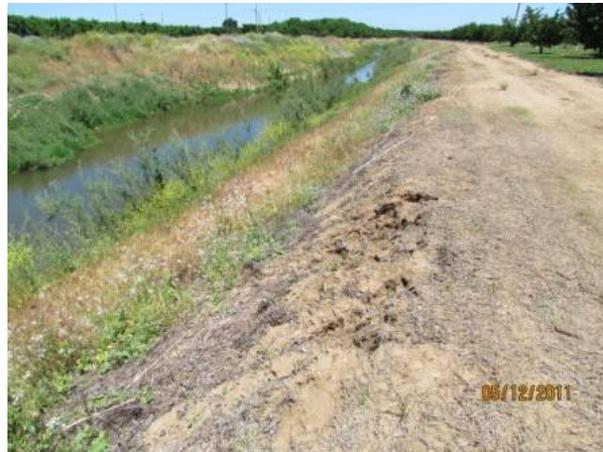
Levee Mile Report Line	98
Start Levee Mile	8.05
End Levee Mile	8.05
Location	Water Side
Category	Earthen Levee
Item	Slope Stability
Slope stability on the shoulder of the waterside of the levee. The picture was taken from the crown looking upstream.	
pkazi_f_20120913_546.jpg

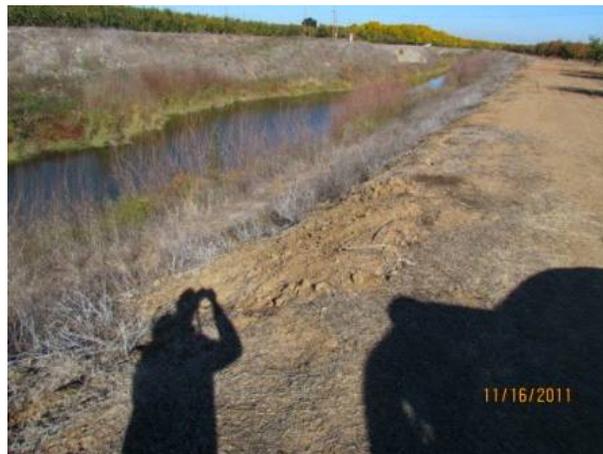
Levee Mile Report Line	98
Start Levee Mile	8.05
End Levee Mile	8.05
Location	Water Side
Category	Earthen Levee
Item	Slope Stability
Slope instability was found on the waterside of the levee looking upstream. This picture was taken during fall 2011 inspection.	
pkazi_f_20120913_547.jpg

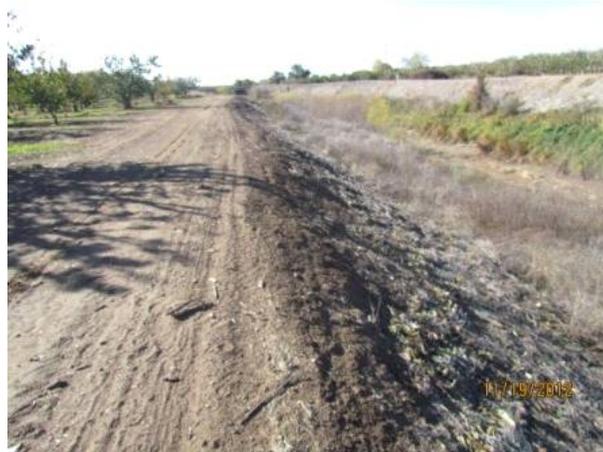
Levee Mile Report Line	101
Start Levee Mile	8.18
End Levee Mile	8.18
Location	Water Side
Category	Earthen Levee
Item	Animal Control
Animal hole was repaired by the LMA on the waterside slope of the levee looking downstream.	
pkazi_f_20121121_134.jpg

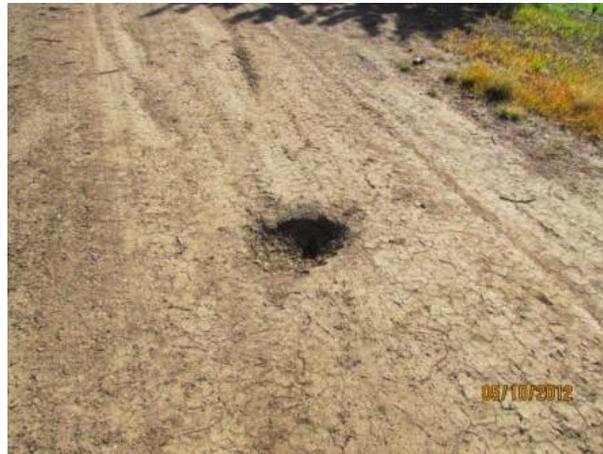
Levee Mile Report Line	103
Start Levee Mile	8.26
End Levee Mile	8.26
Location	Crown
Category	Earthen Levee
Item	Crown Surface / Depressions / Rutting
Depression was found on the crown of the levee looking upstream.	
pkazi_f_20120913_516.jpg

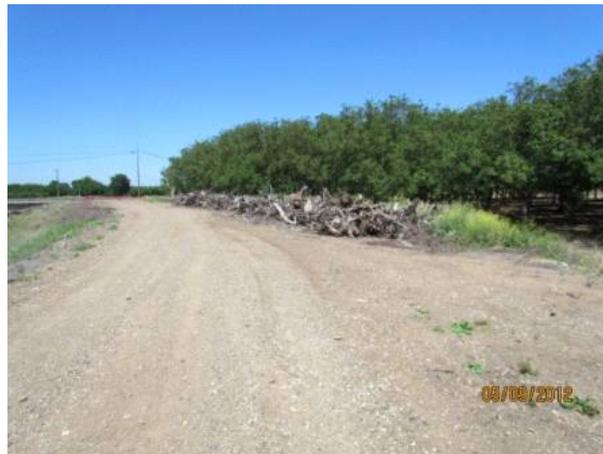
Levee Mile Report Line	104
Start Levee Mile	8.34
End Levee Mile	8.34
Location	Water Side
Category	Earthen Levee
Item	Encroachments
Prunings were found on the landside of the levee looking upstream.	
pkazi_f_20120913_473.jpg

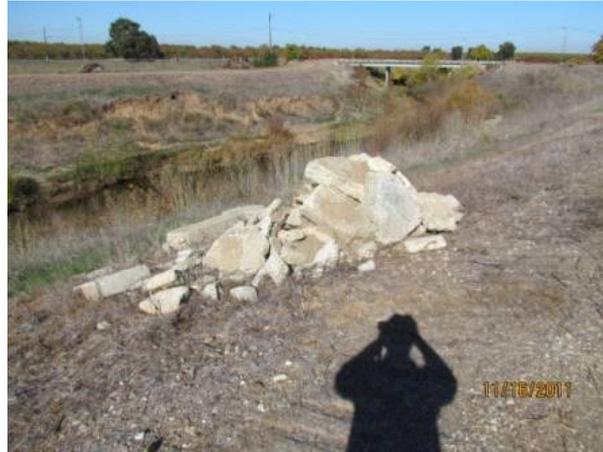
Levee Mile Report Line	105
Start Levee Mile	8.41
End Levee Mile	8.41
Location	Water Side
Category	Earthen Levee
Item	Encroachments
Concrete debris was found on the waterside of the levee looking upstream.	
pkazi_f_20120913_465.jpg

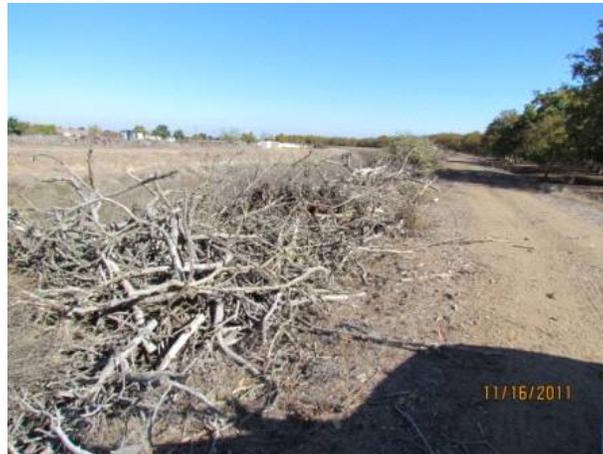
Levee Mile Report Line	107
Start Levee Mile	8.54
End Levee Mile	8.66
Location	Water Side
Category	Earthen Levee
Item	Encroachments
Prunings were found on the waterside of the levee looking upstream.	
pkazi_f_20120913_466.jpg

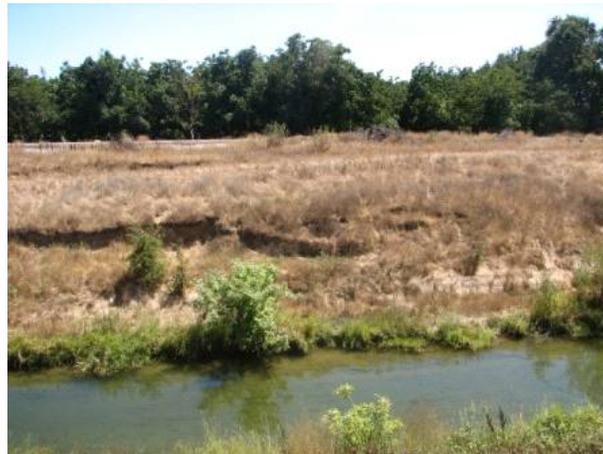
Levee Mile Report Line	108
Start Levee Mile	8.61
End Levee Mile	8.65
Location	Water Side
Category	Supplemental
Item	DWR Erosion Survey
Front view of erosion	
SJR2012_NA0017U16RM14.48_1.jpg

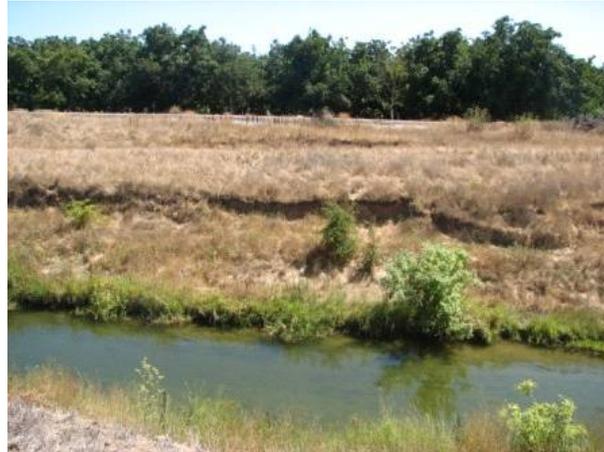
SJR2012_NA0017U16RM14.48_2.jpg

Front view of erosion

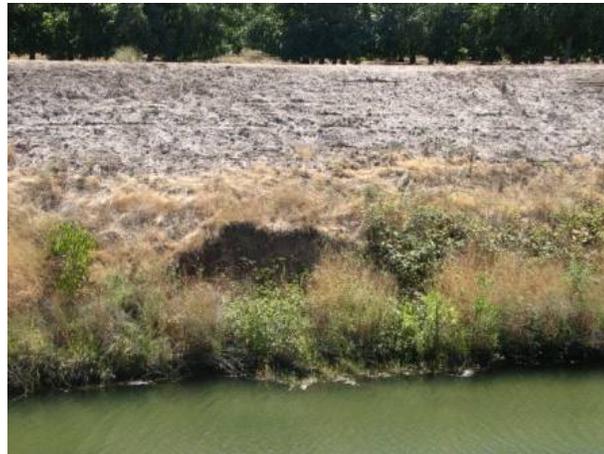
SJR2012_NA0017U16RM13.86_1.jpg

Levee Mile Report Line	110
Start Levee Mile	8.99
End Levee Mile	8.99
Location	Water Side
Category	Supplemental
Item	DWR Erosion Survey

Front view of erosion

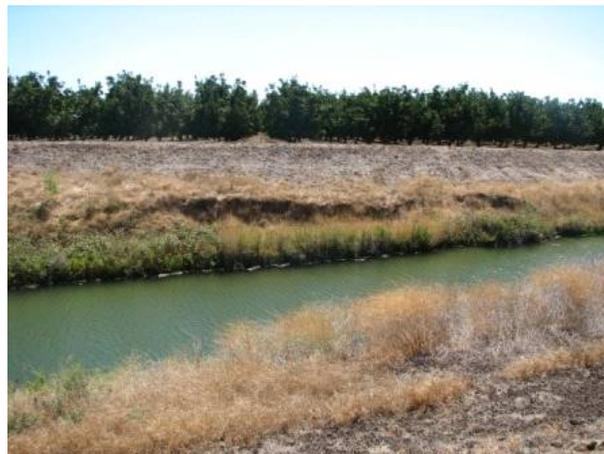
SJR2012_NA0017U16RM13.72_1.jpg

Levee Mile Report Line	111
Start Levee Mile	9.39
End Levee Mile	9.41
Location	Water Side
Category	Supplemental
Item	DWR Erosion Survey

Looking downstream at the erosion
